# CONDOMINIUM WATER TREATMENT

## PROJECT OVERVIEW

**Location: 10 Queens Quay, Toronto, ON**

**Pipe size: 4" DN100 / 6" DN150**

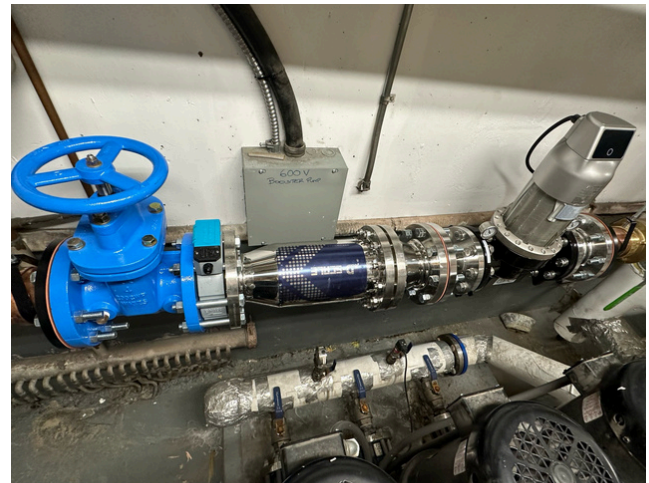
The current conditions of the condominium featured hard water scale buildup in their water systems, decreased flow rates, low equipment efficiency, and excessive consumption caused by hard water for both cooling and heating purposes.

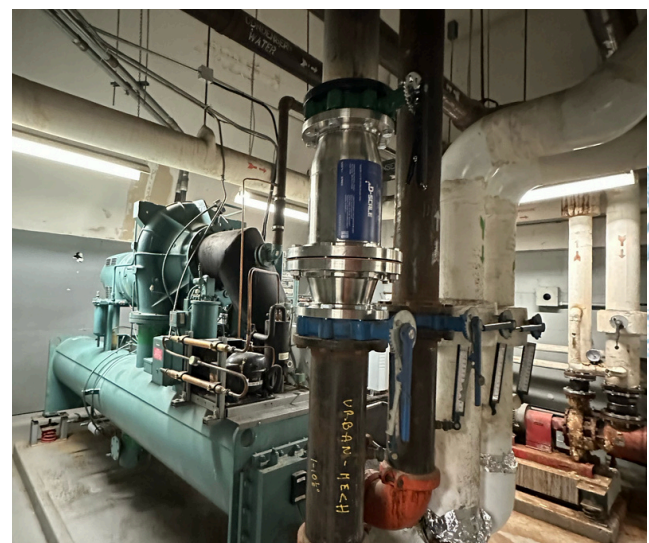
A D-SCALE System DN100 has been installed on the primary domestic water line for pre-filtering, treatment, and to inhibit scale formation and buildup. Additionally, an ultrasonic meter has been integrated to provide precise measurements of water usage.

The D-SCALE Treatment DN150 has also been applied to the York Chiller line to reduce chemical treatment, enhance chiller performance and lower energy consumption.

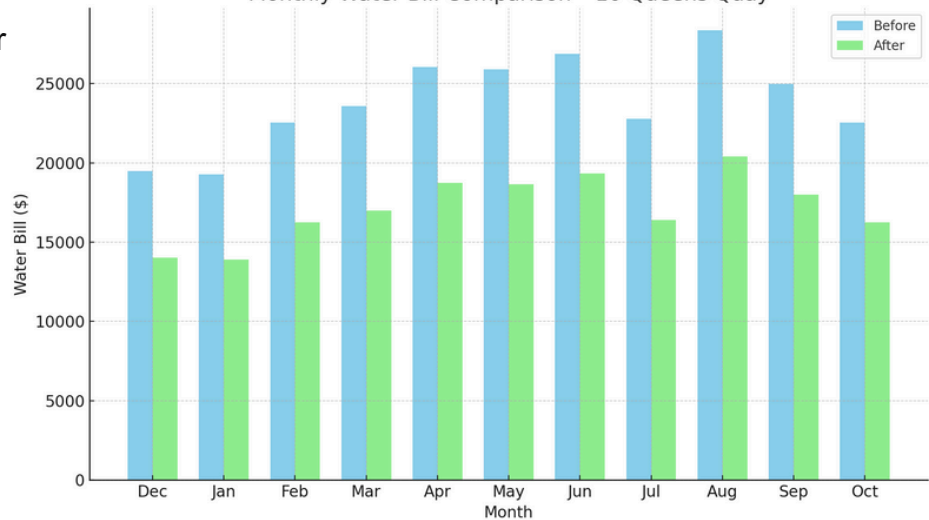
Monthly Water Bill Comparison - 10 Queens Quay

Water consumption was reduced by 28%, resulting in measurable cost savings and more sustainable operations.
